# *Application Note*

## #6

# The Engine Problem That Wasn't

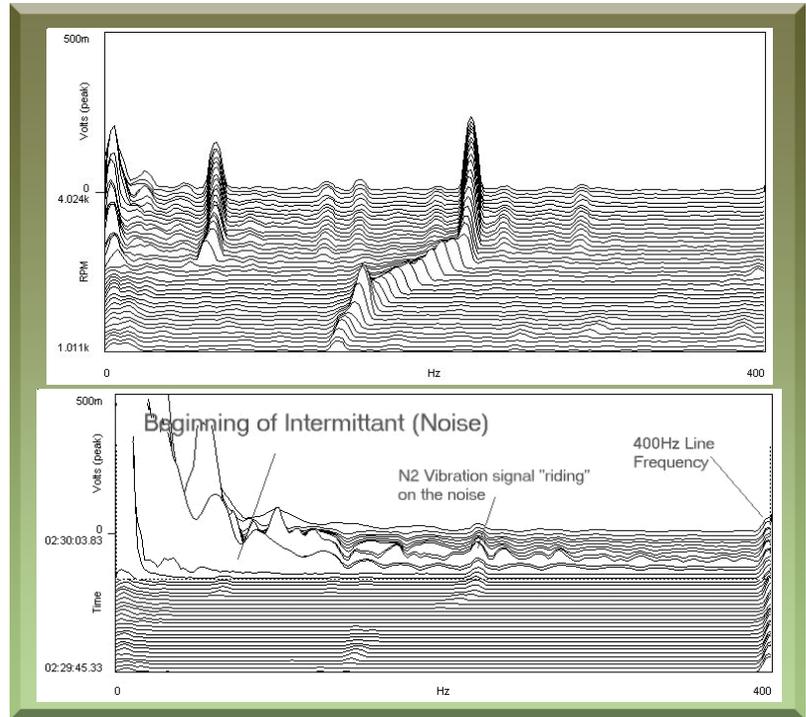
Figure 1. Connector Problem Revealed

The two data traces taken from the GSE are shown in Figure 1. The data represents the engine spooling up from idle at the run-up pad and the start of the aircraft taxi away from the pad and back towards the maintenance hanger. Note on the top trace, the data from the aft sensor appears normal. However, on the forward sensor only faint traces of real engine data can be seen. More significantly, there is a huge jump in vibration level that takes place suddenly and only in the lower section of the vibration spectrum. Also, seen as the highest real signal in the data from this sensor is the presence of a 400 Hz signal that does not change with engine speed. This is an electrical signal that is somehow being detected by the EVM wiring harness. This is something that should not take place.

Armed with these revealing data plots, the correct diagnosis of the problem was made. The forward sensor was fine and in good working order. The EVM was also in good working condition, and properly reporting the apparent vibration levels that it was "seeing." What had failed was the cable system that was in between the sensor and the EVM system. As it turns out, it was a contaminated connection point. All the symptoms match and are in perfect agreement for a relatively inexpensive repair.
